Case Study of Envelope Sealing in Existing Multiunit Structures

Jordan Dentz, Francis Conlin,
and David Podorson
ARIES Collaborative

October 2012

ARIES Collaborative

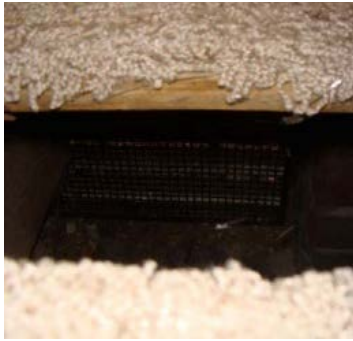
Figure 5. Before: Disconnected duct boot behind floor register

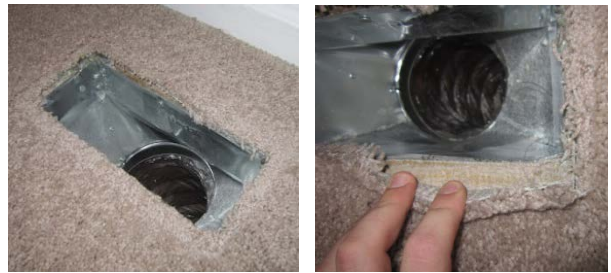
Figure 6. After: Boots sealed to subfloor

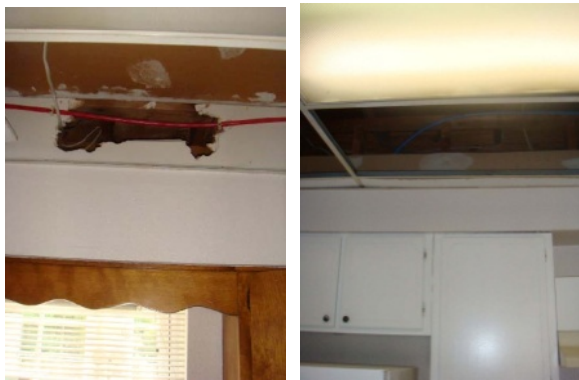
Figure 7. Before: Openings in walls above dropped ceiling in kitchen

^a The large leakage reduction in 2030 unit 8 and 2330 unit 7 when the kitchen was sealed off was caused by the fact that the space above the dropped ceiling in the kitchen was completely open to the wall cavity.

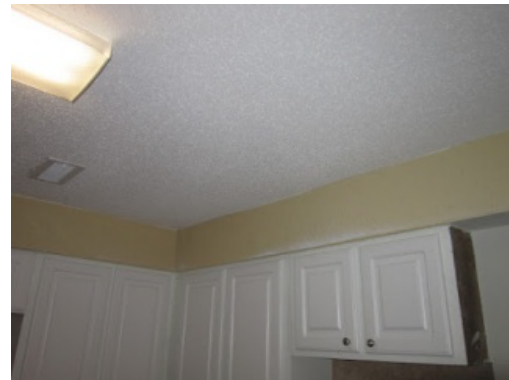
Figure 8. After: New gypsum board ceiling in kitchen isolates wall penetrations from living space

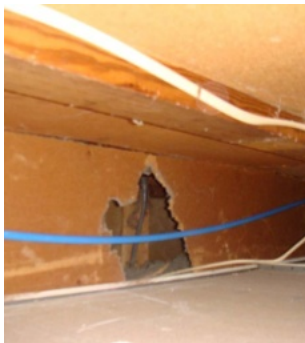
Figure 9. Before: Opening in wall above dropped ceiling

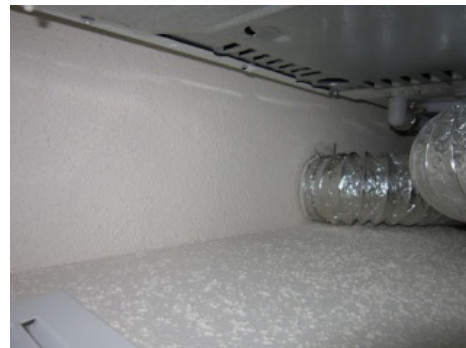
Figure 10. After: Sealed wall above dropped ceiling

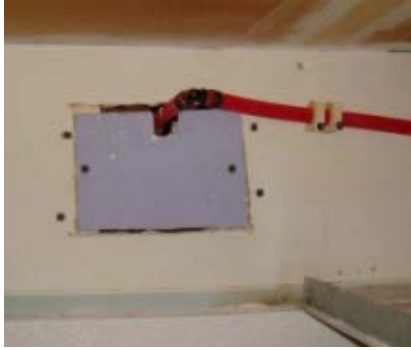
Figure 11. Before: Poorly patched plumbing opening in wall above dropped ceiling

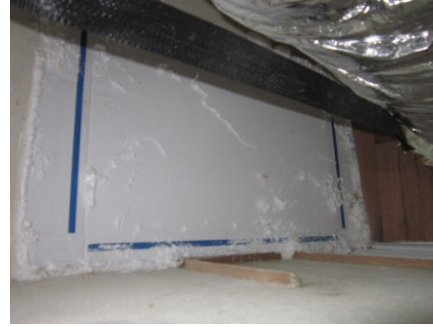
Figure 12. After: Opening in wall above dropped ceiling patched and sealed

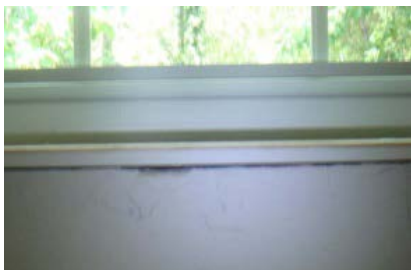
Figure 13. Before: Gaps around window sill resulting from poor installation of windows

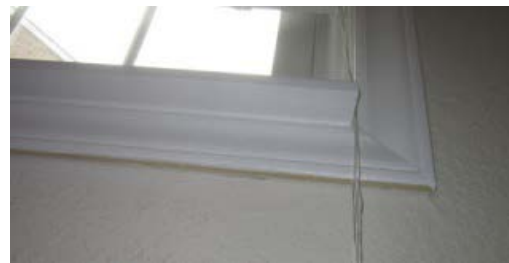
Figure 14. After: Window sill sealed to wall with caulk

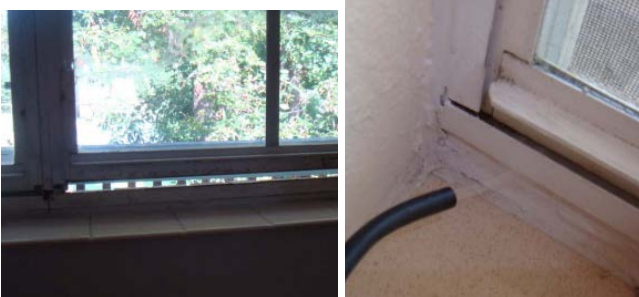
Figure 15. Before: Old windows not closing tightly

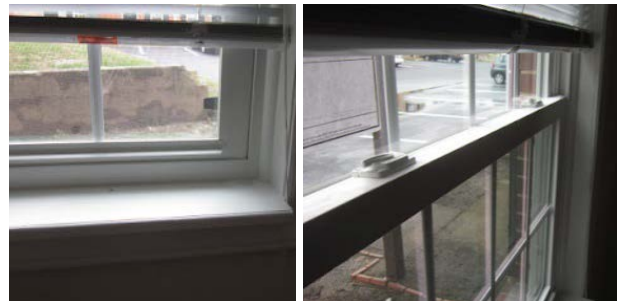
Figure 16. After: New tightly closing windows

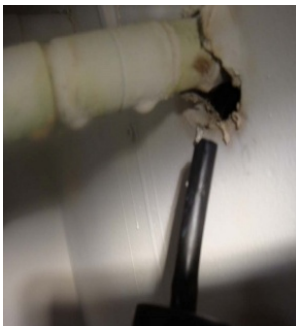
Figure 17. Before: Opening in wall around pipe being tested with smoke stick reveals air pathway

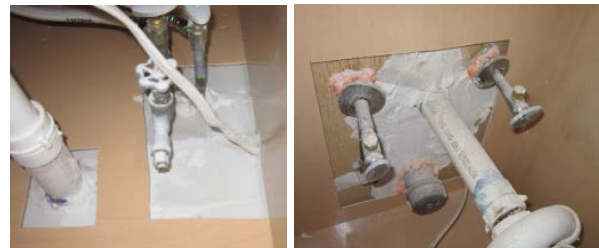
Figure 18. After: Plumbing penetrations sealed around pipes and behind escutcheons with foam and caulk

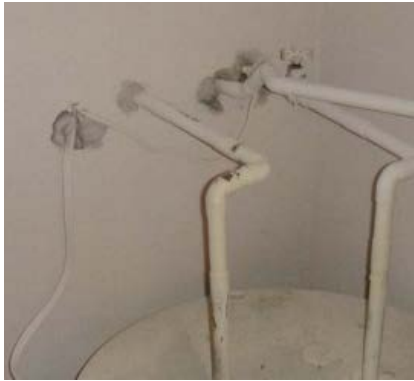
Figure 19. Before: Openings around water heater pipe penetrations

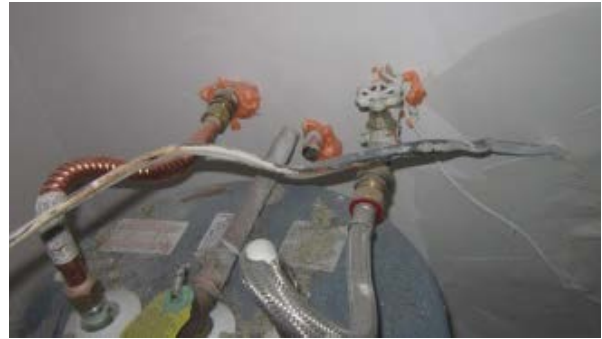
Figure 20. After: Water heater pipe penetrations sealed with foam

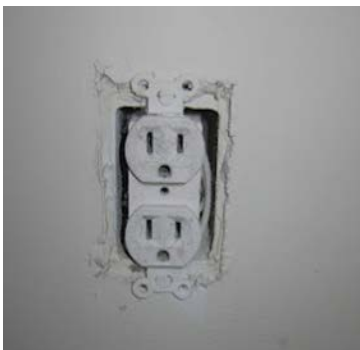
Figure 21. After: Outlet sealed to wallboard around perimeter

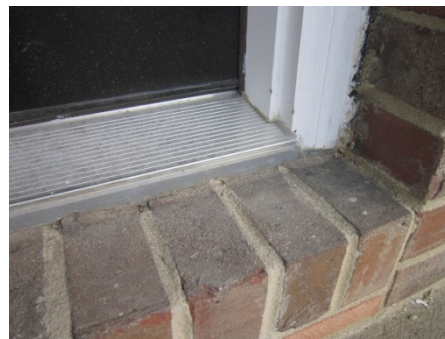
Figure 22. After: New door sweep and sill sealed to brick

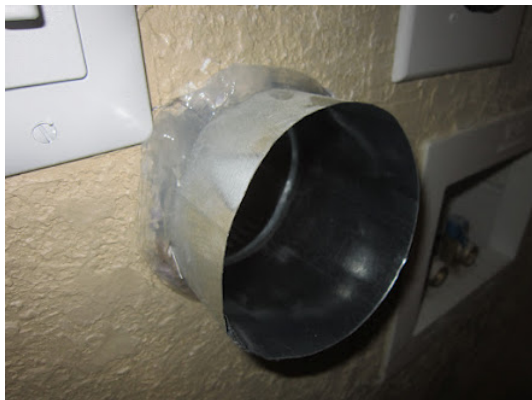
Figure 23. After: Dryer exhaust duct sealed to wall with caulk

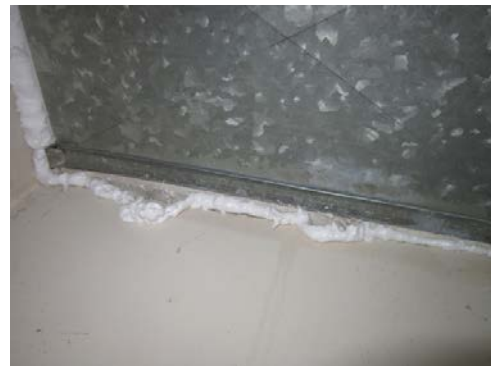
Figure 24. After: Gap around supply duct sealed with foam

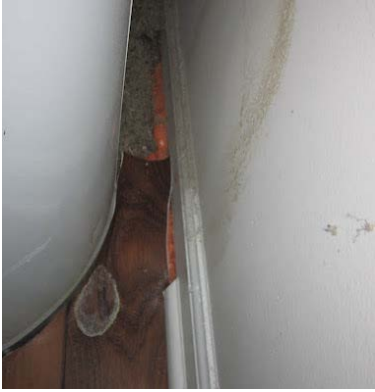
Figure 25. After: Crack under wall in mechanical space sealed to floor with foam

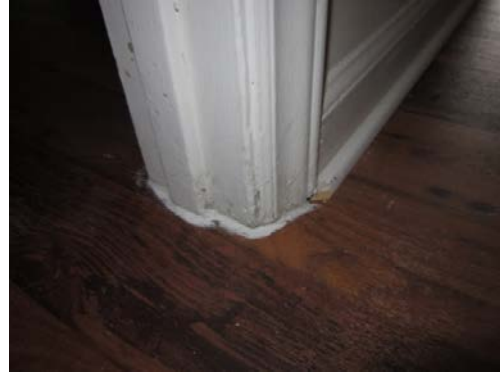
Figure 26. After: Crack at bottom of door jamb sealed to floor with caulk

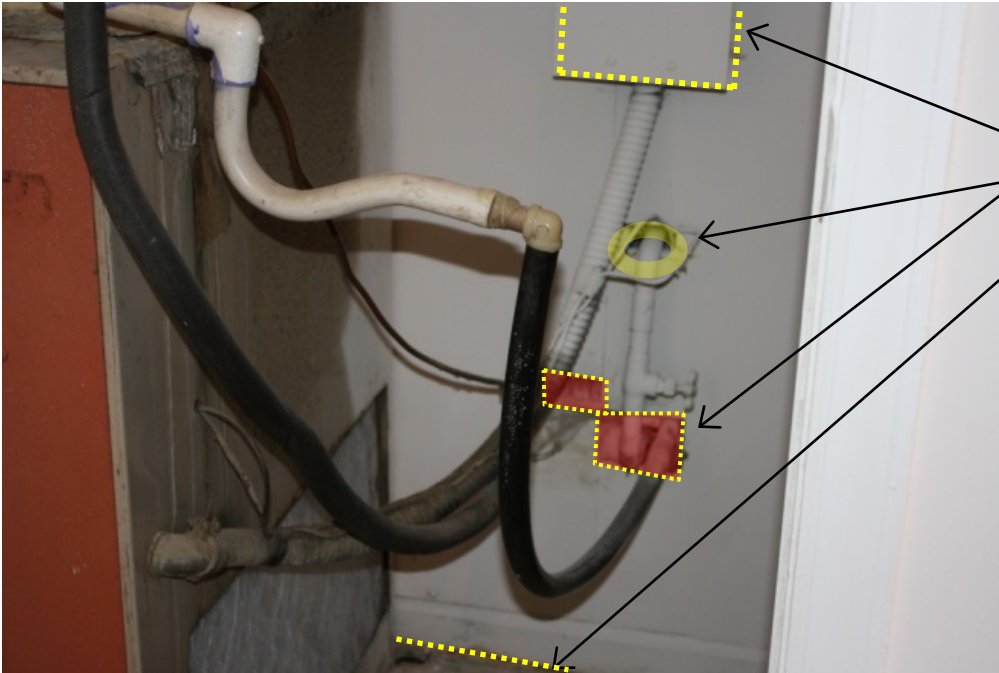
Typical electrical and mechanical piping penetration in HVAC return closet

1. Seal electrical boxes to wallboard with foam or caulk.
2. Make piping penetrations airtight, using sealants, foam, and plugs.
3. Seal all transitions in HVAC return closet between floor and wall and ceiling and wall

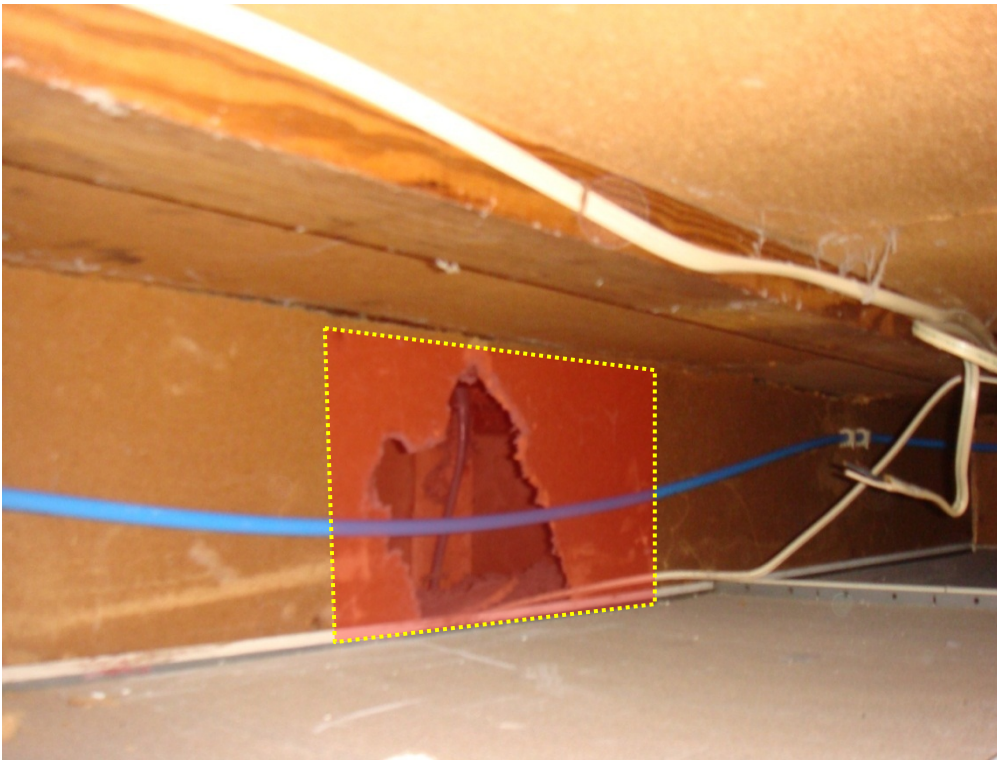
Typical void above kitchen area dropped ceiling

Install patch or plug and mechanically fasten to substrate, then make airtight with sealant or fluid-applied membrane around perimeter.

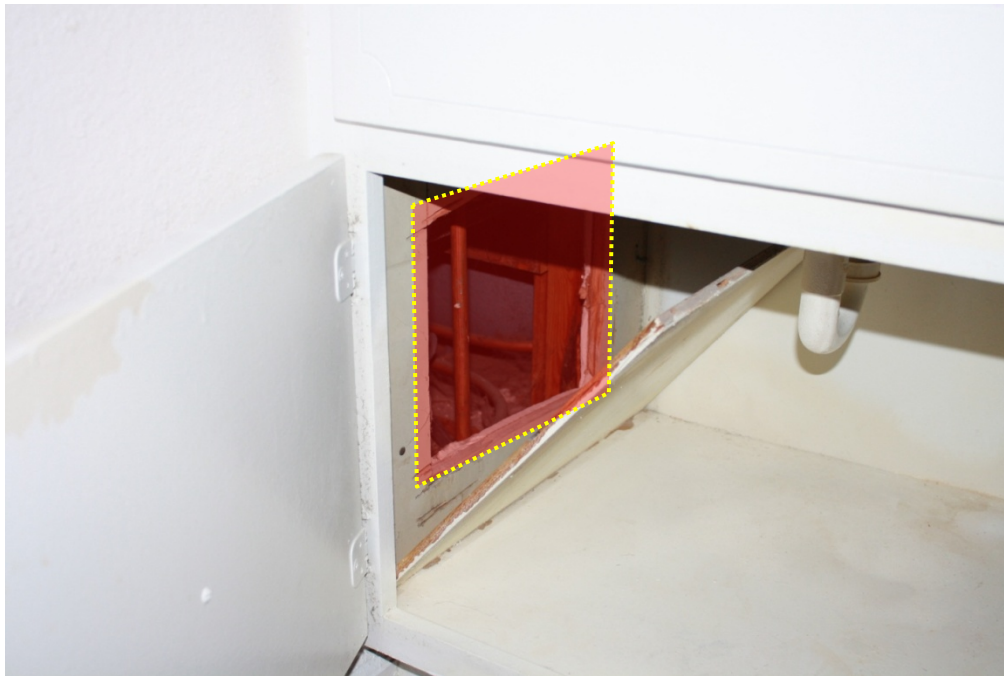
Typical access void behind tub in bathroom

Install patch or plug and mechanically fasten to substrate, then make airtight with sealant or fluid-applied membrane around perimeter.

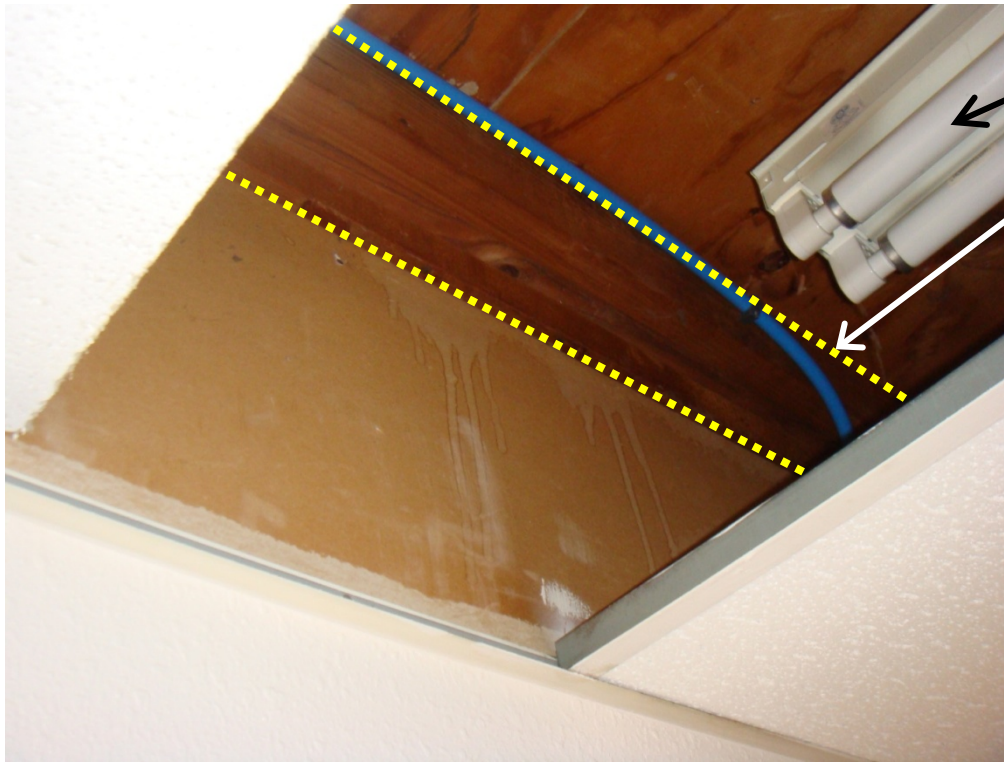
Typical kitchen area above dropped ceiling

Seal attic penetrations for light fixture above dropped ceiling, or remove fixture entirely and repair air barrier.

Seal drywall and ceiling lid to structure with a continuous bead of caulk or joint sealant.

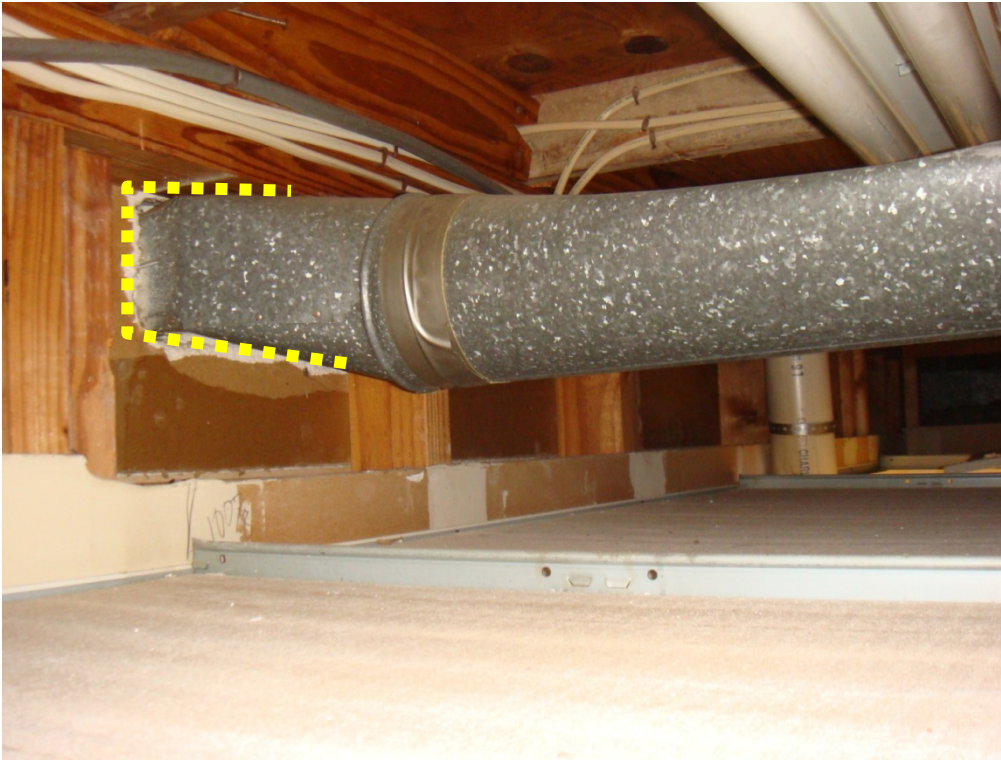
HVAC duct penetration through air barrier

Install sealants or membranes with backer rod or transition strips as necessary to make duct penetration airtight.

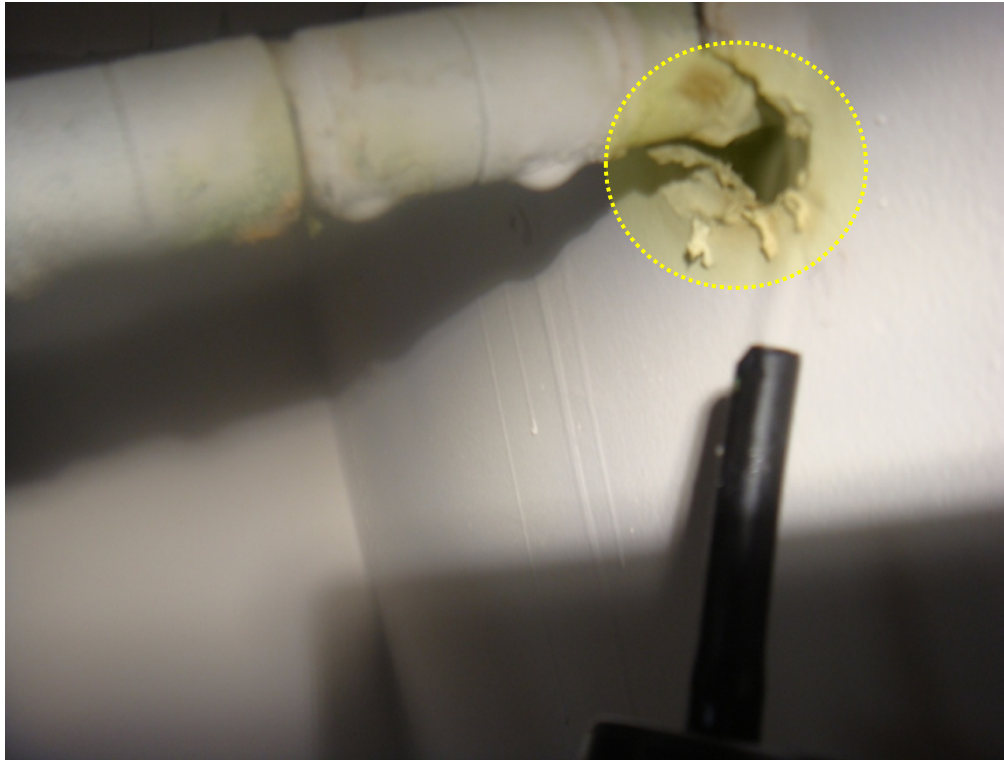
Typical unsealed plumbing penetration under sink

Air seal between the plumbing penetration and the
GWB air barrier using continuous beads of spray
foams or fluid membrane with transition strips.

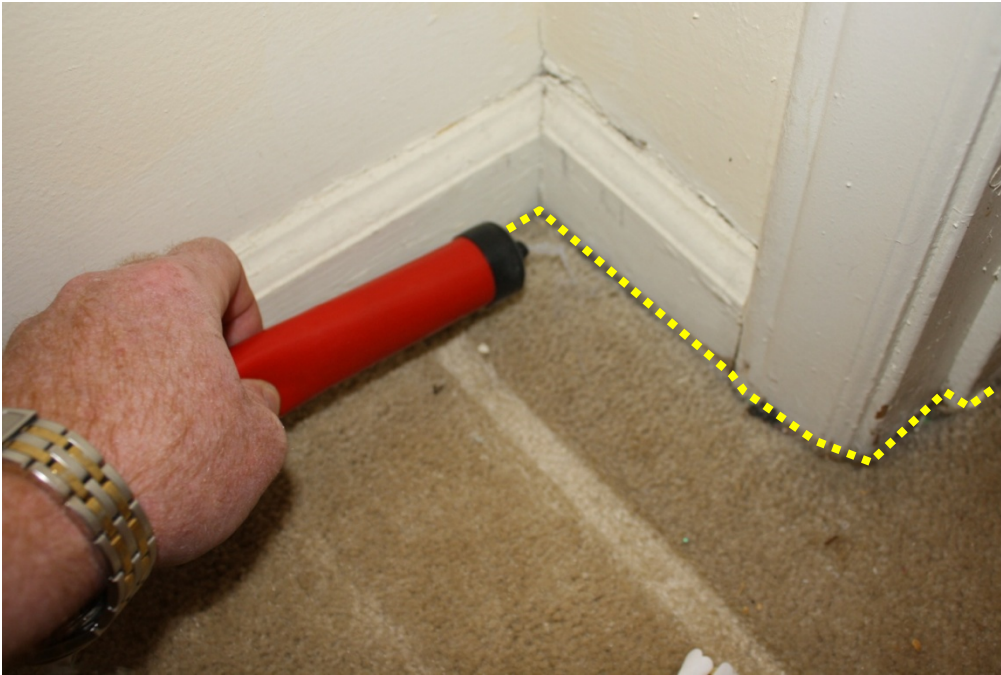
Floor to wall transition

Pull carpeting away from wall. Clean area to ensure sealant adhesion and install a continuous bead of sealant to make floor-to-wall intersection airtight. Use backer rod to support sealant at openings greater than $\frac{1}{4}$ in., or the distance described in the sealant manufacturer's installation instructions.
